## DAMAGE REPORT, STORM MOORING PROCEDURES AND PRECAUTIONS, SEQUENCE OF THE EVENT AND YACHT EVALUATION

The subject yacht was holed and sank in her slip by another yacht. The subject yacht was deemed a C. T. L. (Constructive Total Loss) raised and taken to a salvage yard for disposal. See CONCLUSION AND OPINION and CAUSE OF LOSS

### CONCLUSION AND OPINION on CAUSE OF LOSS

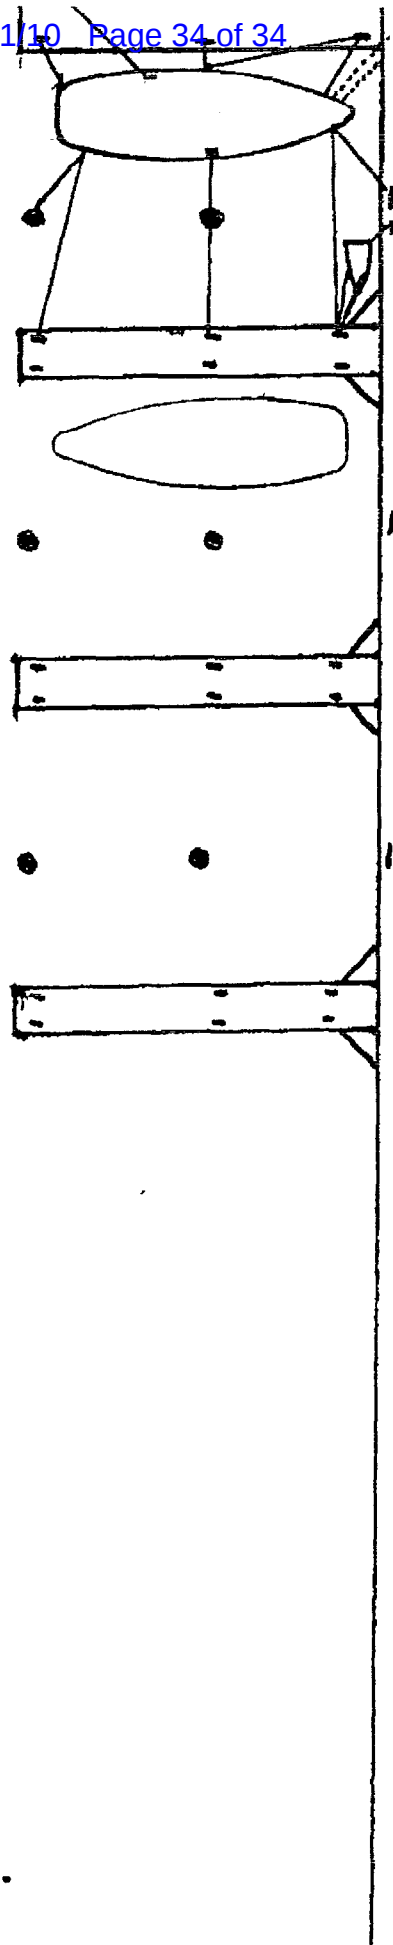
1) The JEANETTE MARIE was very poorly secured for the storm that was predicted to hit. She was moored with mostly small diameter line, mostly old, chafed and worn line and clearly no additional lines were used on her port side. See drawing A and photos 1-16.

It is very clear that very poor preparation was made to secure the JEANETTE MARIE in advance of this storm. The mooring lines were at best 5/8" or 1/2" in diameter and the boat appeared to be only secured with single lines at the bow and stern. (Note: There was more than adequate warning, at least 72 hours notice that this storm was going to impact this area) It is clear from the photographs reviewed that the JEANETTE MARIE had broken loose from her slip, crashed through a finger pier and crashed into Mr. Gladdens boat.

There was no evidence of the failure of the dock that the JEANETTE MARIE was moored to. None of the mooring cleats had pulled out of the dock. The boat clearly broke loose because the mooring lines were in poor condition and too small for this size boat.
